Oakham Castle Community Dig 2018

Interim Report

Mathew Morris MA ACIfA

Project Officer, Archaeological Services (ULAS)

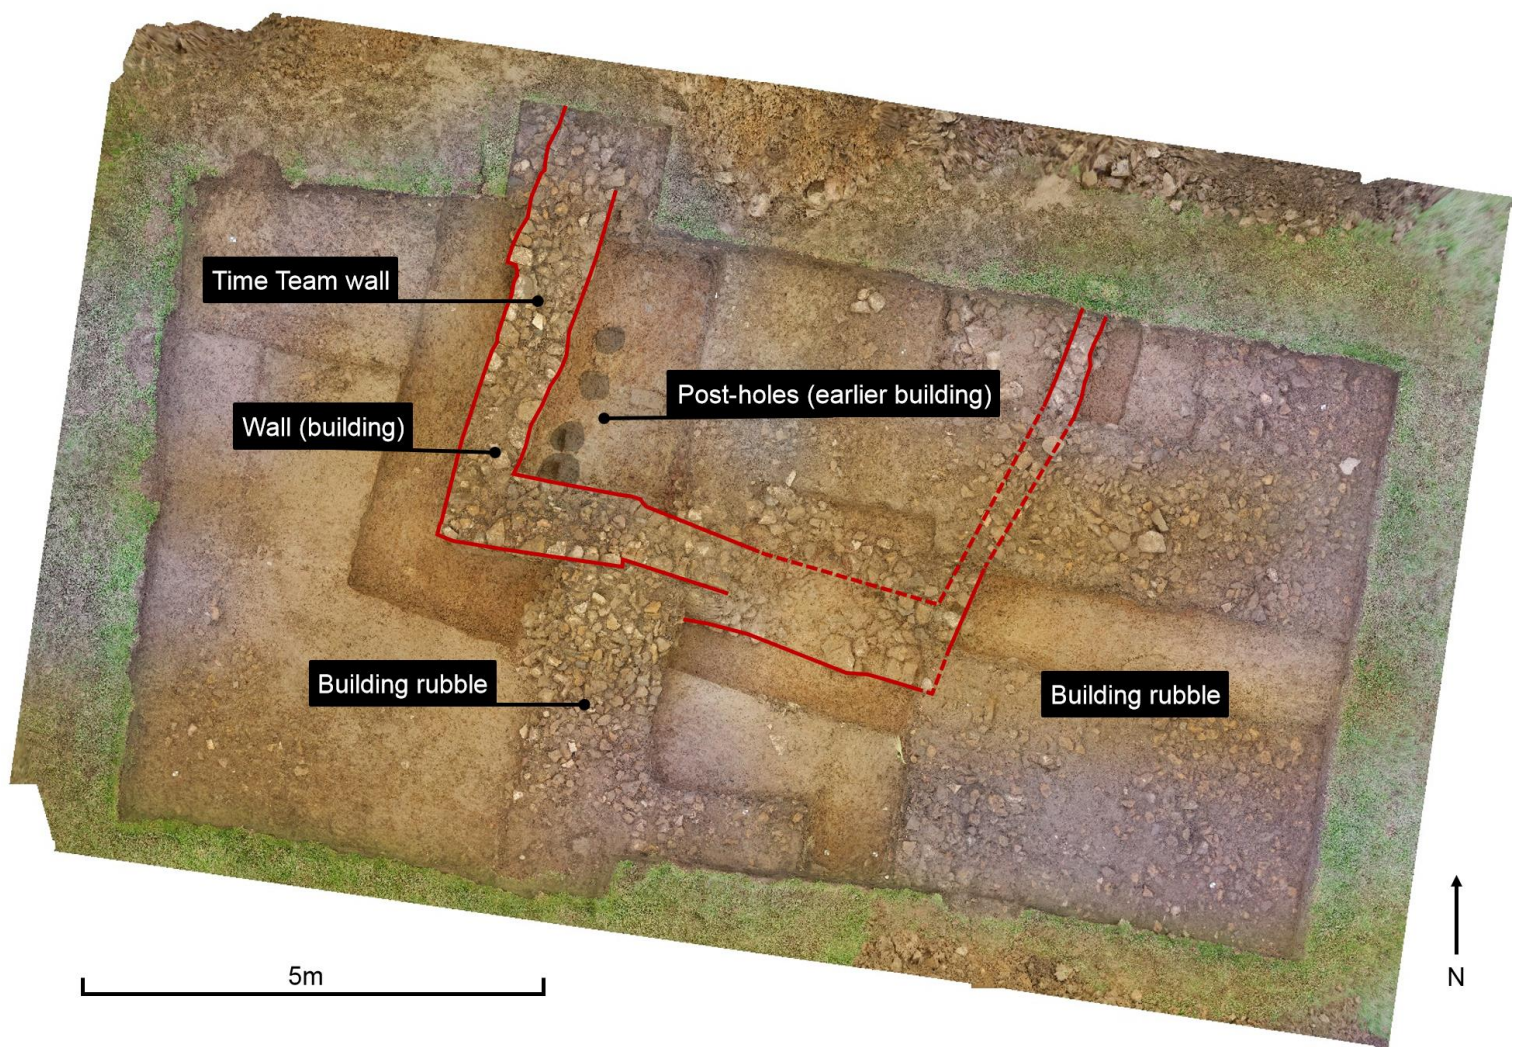
Above: A vertical view of the archaeology in Trench 1. A 3D model of Trench 1 can be viewed at <https://skfb.ly/6yPnH>

North of the hall, Trench 1 focused on a series of earth mounds in the north-east quarter of the castle's inner bailey. Here, in 2012, Channel 4's Time Team identified a sizeable stone wall, thought to date to the 13th or 14th century. Removal of turf and topsoil with a mechanical digger revealed that the earth mounds within the trench area were large piles of rubble, presumably from the demolition of an underlying building.

Beneath the rubble was the southern end of a long narrow building (5m wide inside). In places, the walls still stood to waist height, but whilst they were built of stone, construction was crude and the building only had an earth floor. The eastern side of the building also appeared to be less well built than the other sides and may have been open, perhaps facing a yard to the east. Current thinking is that this was probably one of the many service buildings in the castle, perhaps a stable or workshop.

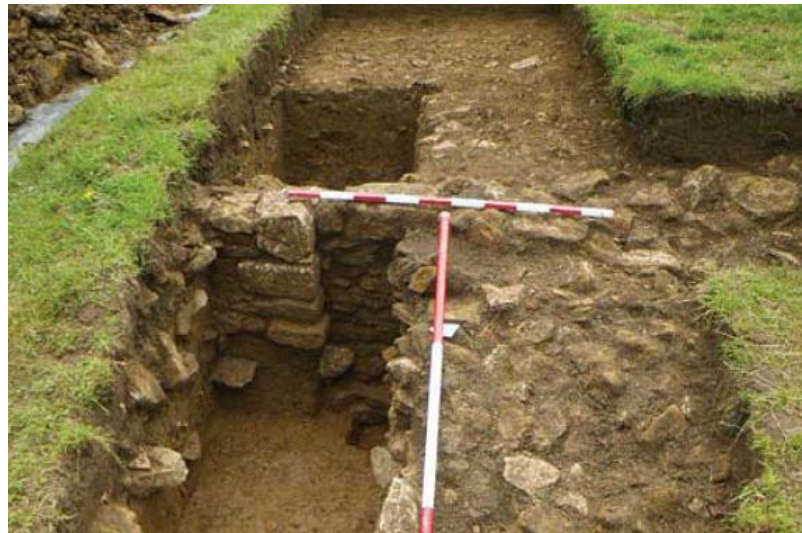
Above: A medieval stone wall found by Channel 4's Time Team north-east of the Great Hall in 2012.

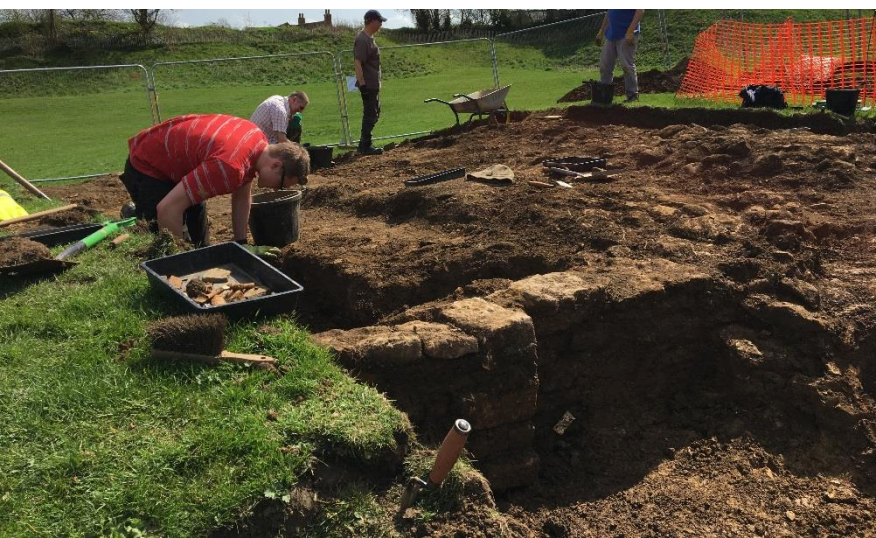
Left: Part of Time Team's wall is found again in 2018. The wall was buried beneath a thick layer of rubble left behind following the building's demolition.

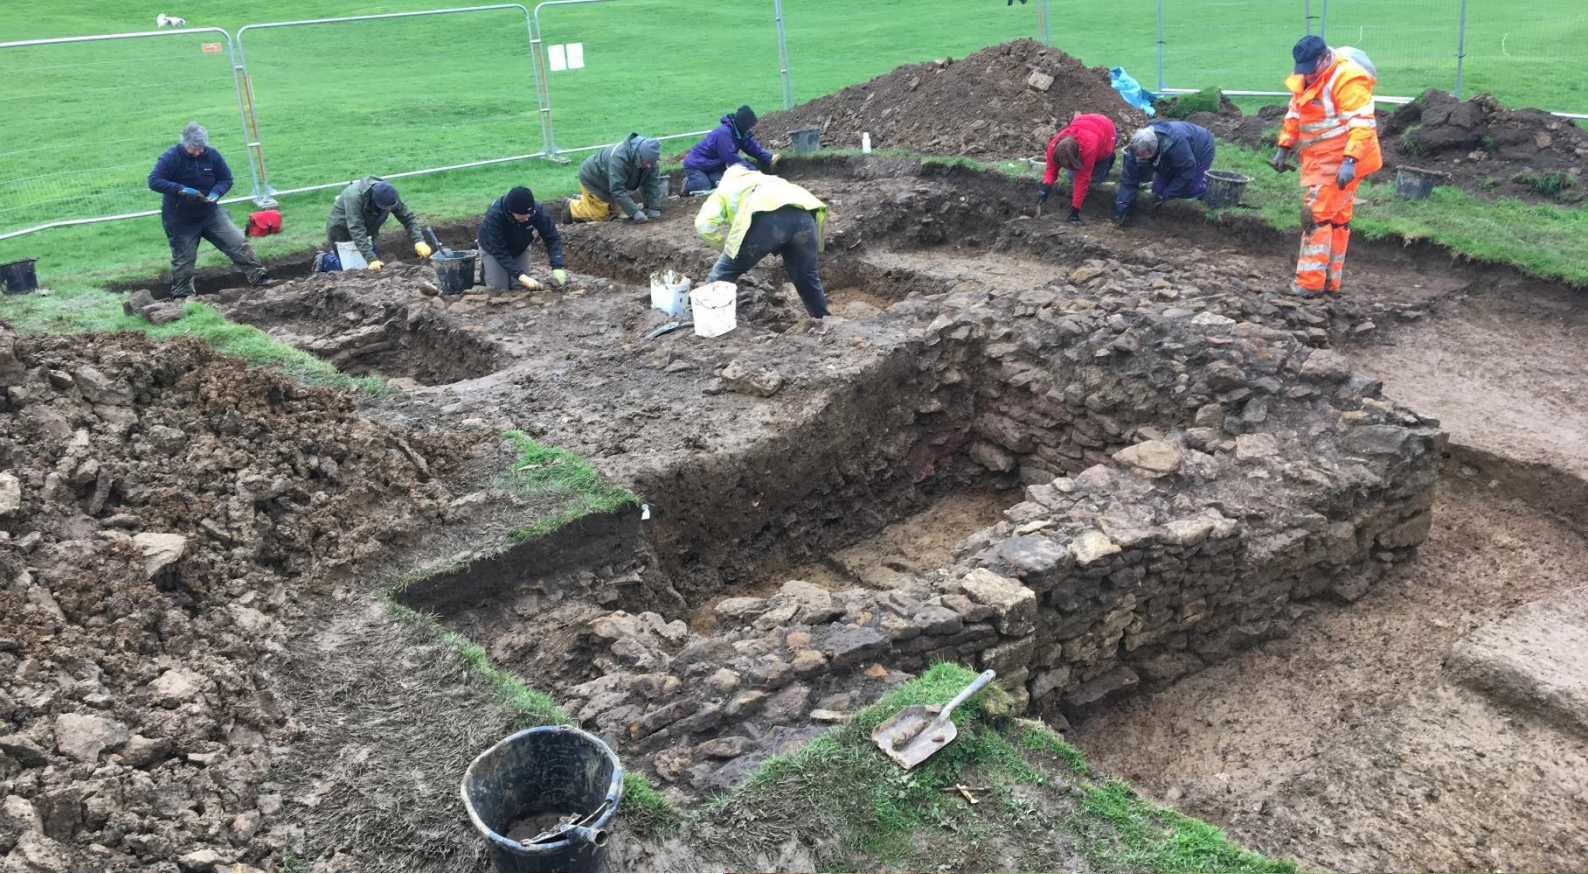
Top right: The stone wall, fully uncovered in 2018, was the south-west corner of a building.

Bottom right: Scorching inside the building was evidence of re-use of the derelict structure.

Soil around the southern side of the building produced large quantities of animal bone, many showing butchery marks, as well as sherds of 12th- to 14th-century green-glaze table wares and plainer kitchen wares – all probably waste from the castle's kitchen located nearby. Excavation also revealed that the building had gone through a prolonged period of neglect and reuse before it was eventually demolished, including a fire in the 'derelict' structure which had scorched the stones of the southern wall. Again, this fits

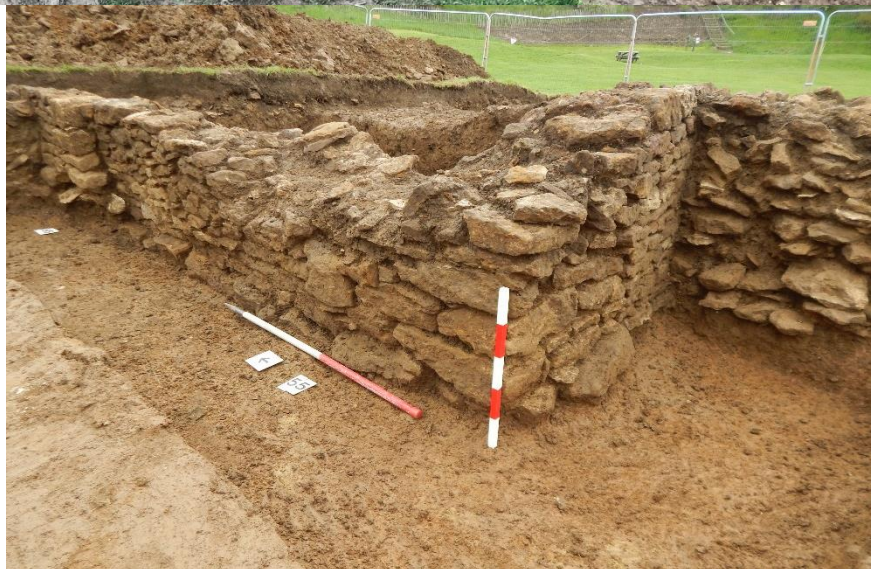
Far right: A row of post-holes beneath the building was evidence of an earlier structure on the site.

Exciting evidence found in the last days of the dig (a row of four post-holes) now also suggests that there was an earlier timber structure beneath this building, which could be evidence of the original Norman castle, although so far an exact date is not forthcoming.

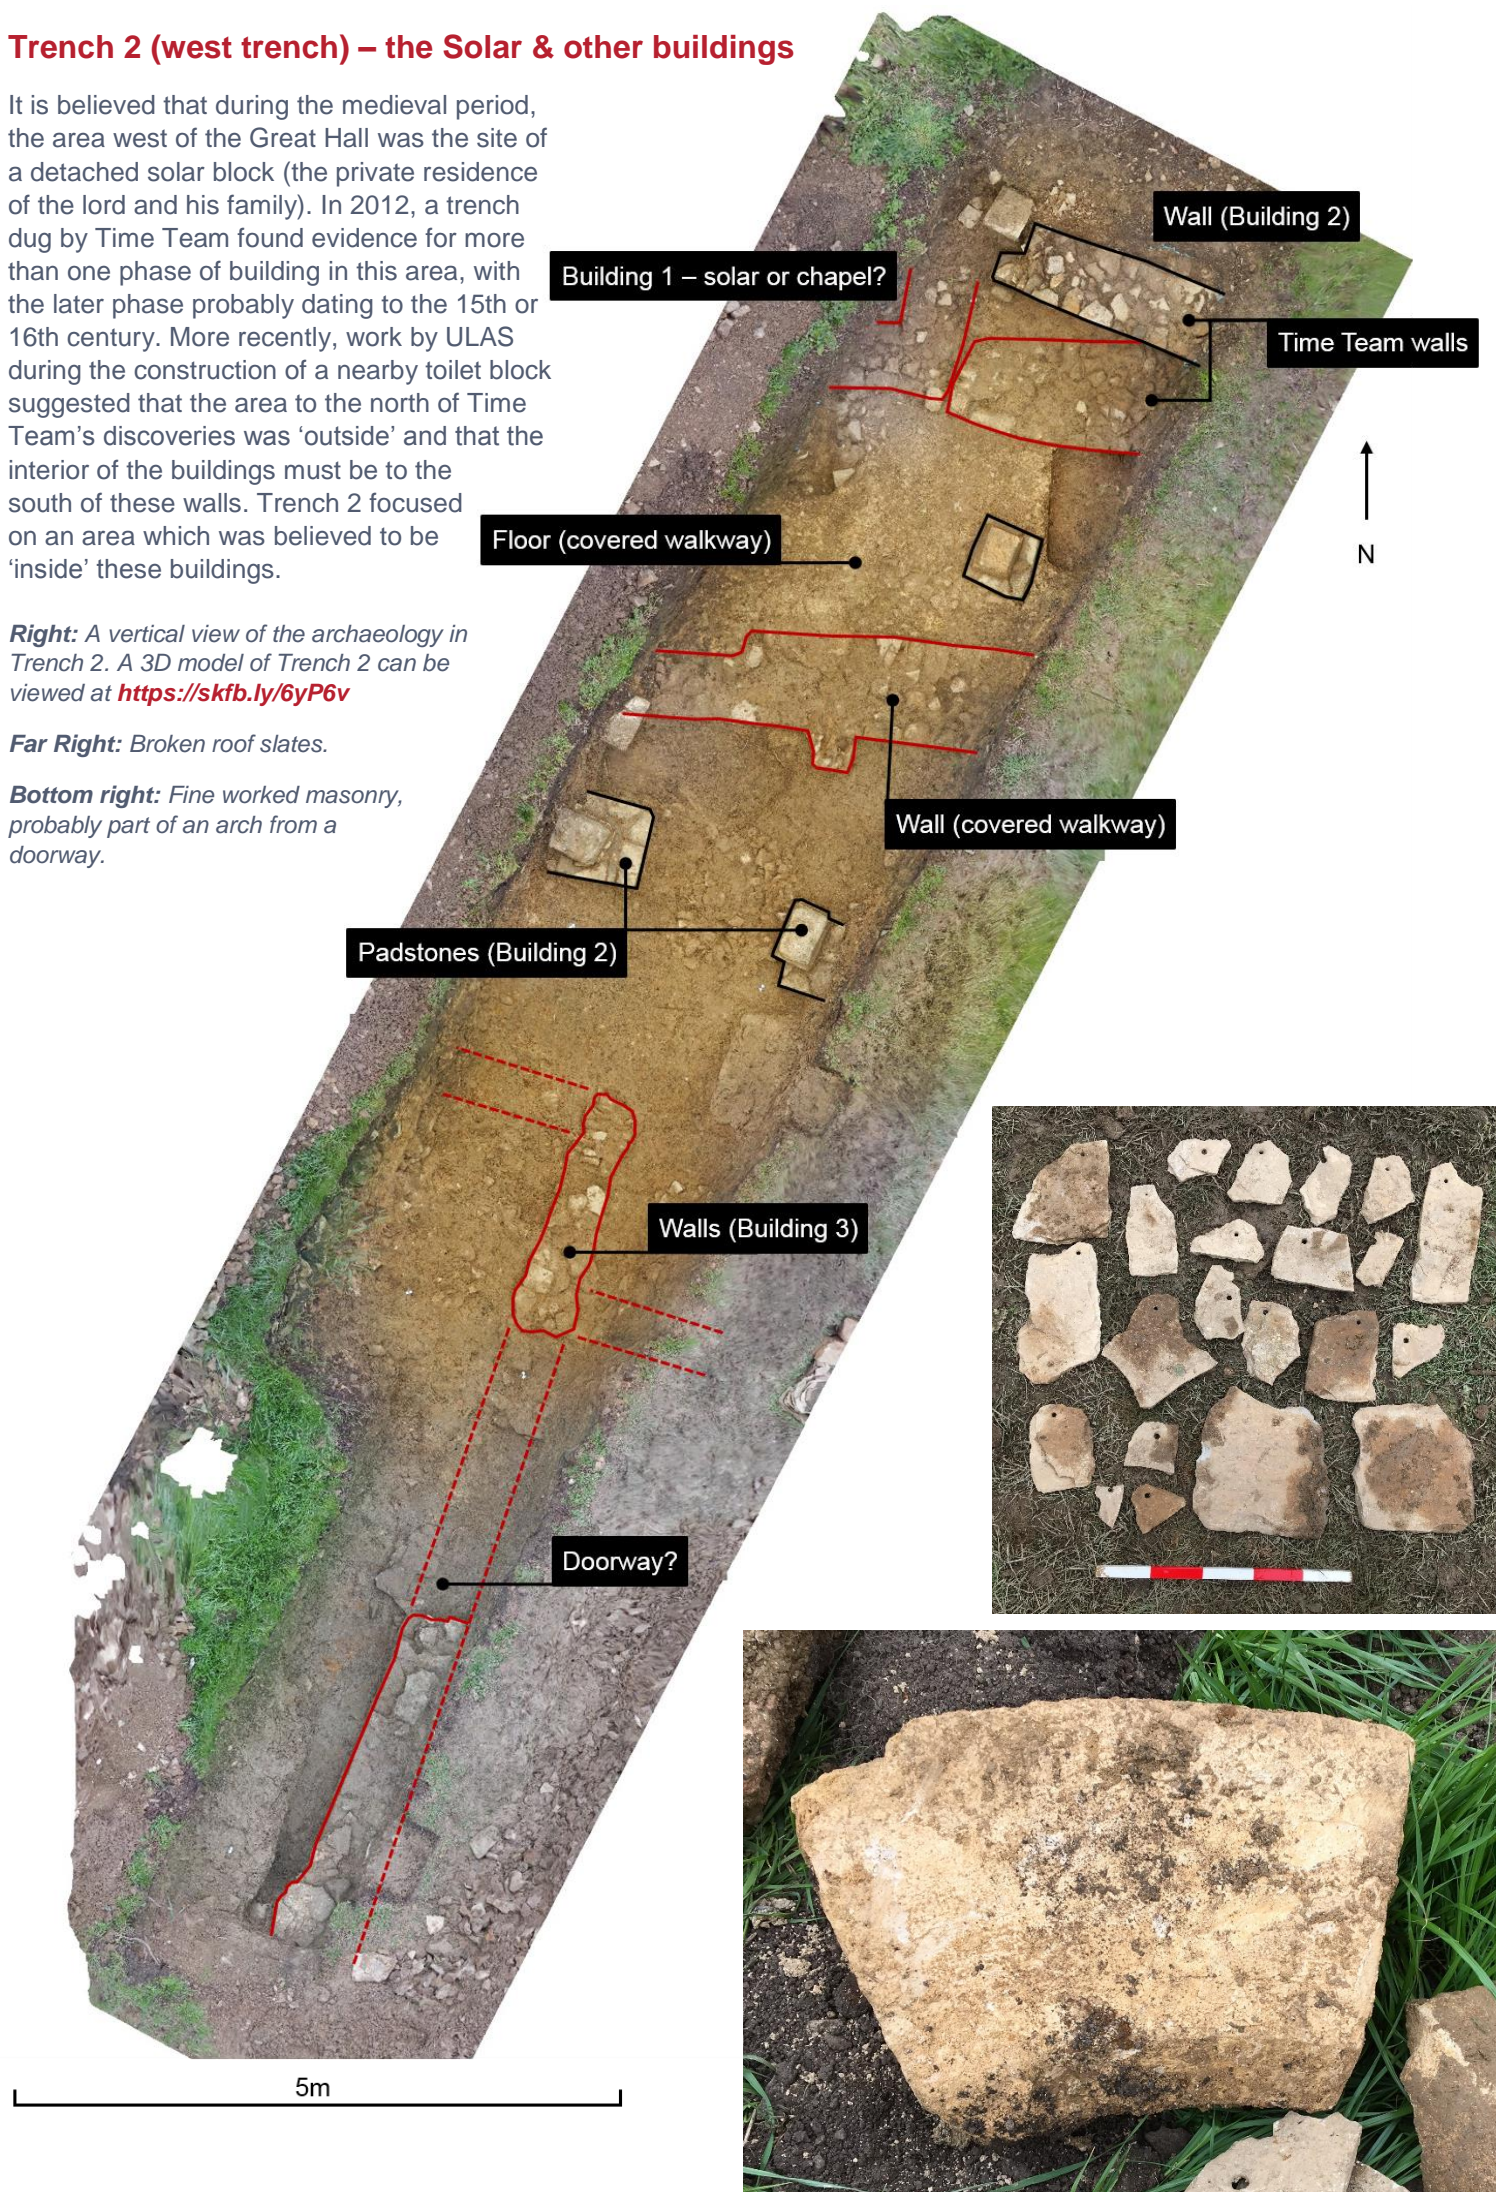
Right: A vertical view of the archaeology in Trench 2. A 3D model of Trench 2 can be viewed at <https://skfb.ly/6yP6v>

Beneath the rubble at the northern end of the trench, a complicated sequence of buildings with evidence for multiple phases of rebuilding was uncovered. It appeared that the walls first discovered by Time Team were part of two stone buildings constructed close to the curtain wall. The earlier building (Building 1) was connected to the north aisle of the hall by a pentice (covered) walkway and appeared

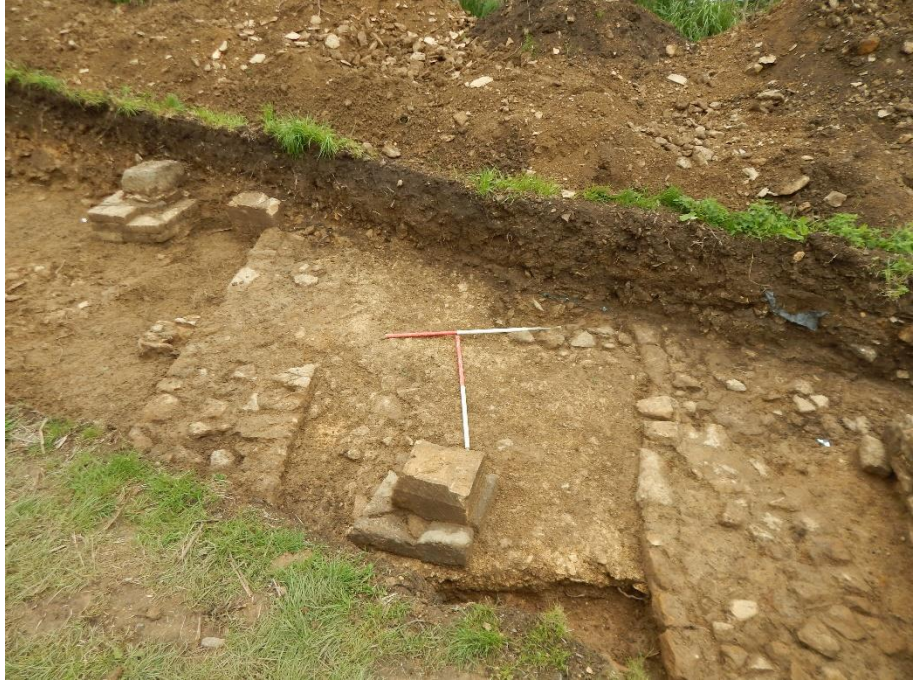
Above: Looking west at the covered walkway attached to Building 1.

to date to the castle's heyday in the 13th and 14th century. The walkway was 2m wide and had a sturdy stone and mortar floor and may correlate with an Inquisition of 1375 which refers to the building of a new chapel and chamber, the chapel being connected to the hall by a passageway.

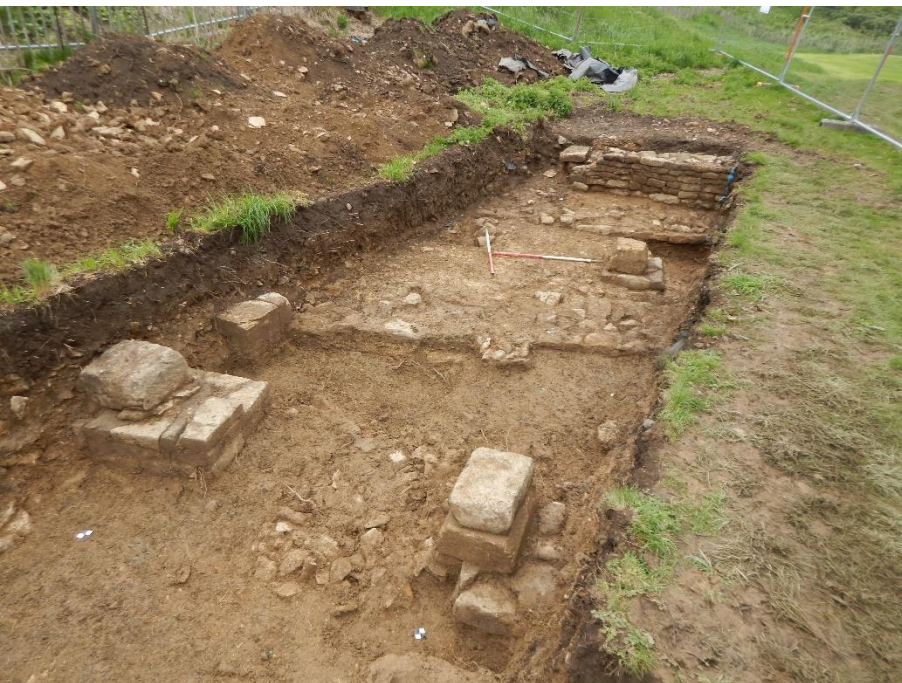
Above: Looking north at the padstones and wall of Building 2, built over the remains of Building 1.

At a later date, probably in the 15th or 16th century, Building 1 and the passageway were demolished and replaced with a large timber post-built structure (Building 2). The northern side of the building was supported by a stone wall but the rest of the structure was supported by sturdy vertical timber posts which rested on large square padstones.

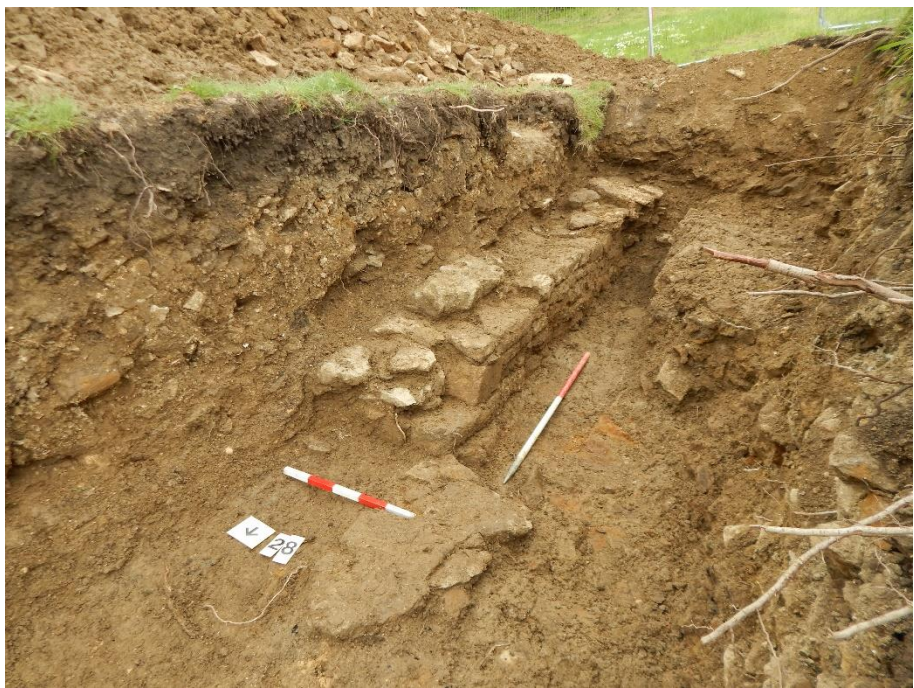
Right: Looking south at the remains of Building 3. A section of wall survived with the room (to the right) filled with building rubble. There is a possible doorway with a stone threshold where the wall ends in the foreground of the photograph.

A third stone building, also probably of 15th or 16th century date, was identified at the southern end of the trench. It was also probably built against the curtain wall and appeared to have a threshold and doorway on its eastern side. However, not enough of this building was uncovered to know whether it was contemporary with Building 1 or 2 to the north, although 15th-century pottery from beneath the threshold suggests the latter. As in Trench 1, evidence shows that the remaining buildings west of

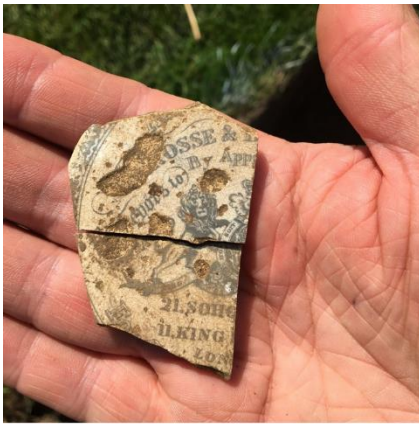
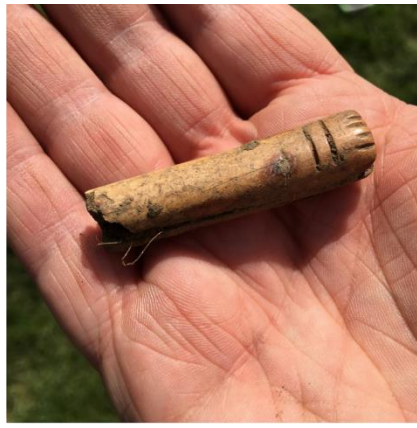
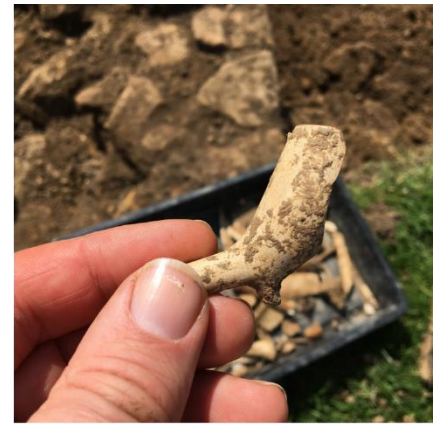
Top row (l-r): Post-medieval finds from Trench 1 - part of a jar lid of Crosse & Blackwell anchovy paste (c. 1839), a bone knife handle, and part of a clay tobacco pipe bowl.

The topsoil contained finds dating to the late 17th, 18th and 19th centuries – pieces of clay tobacco pipe, pottery, china, animal bone, iron nails, copper buttons, a bone knife handle and part of a jar lid for Crosse & Blackwell anchovy paste (c.1839). This 'rubbish' was probably dumped here by the people of Oakham after the castle had been abandoned, the site becoming a convenient place to dispose of refuse from the 17th century onwards.

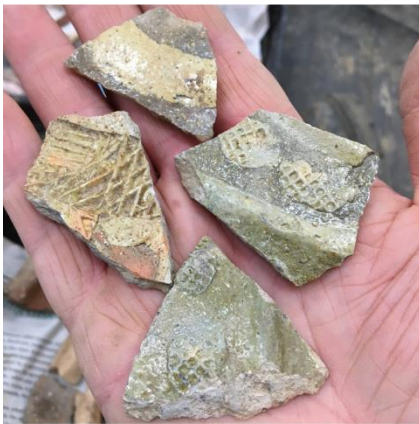
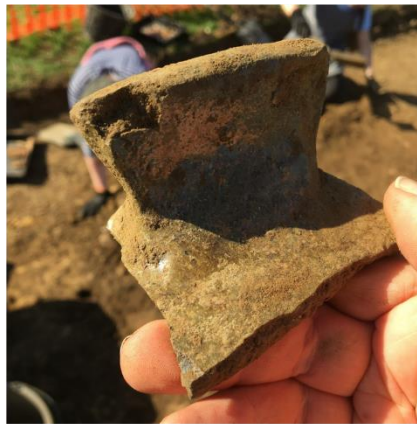
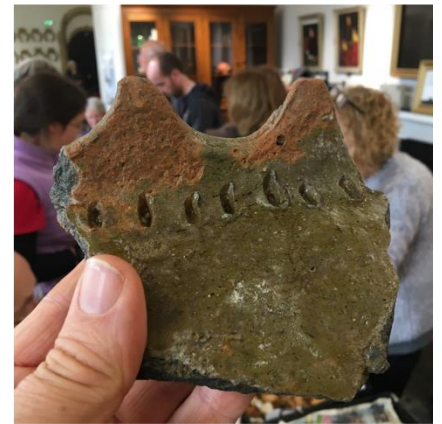
Third row (l-r): Sherds of decorated tableware (c. 1225-1400) from Trench 2, decorated glazed ridge tiles from Trench 1 and Trench 2.

As yet, not enough evidence has been found to say conclusively what these buildings were used for. However, finds of decorated green-glazed table wares, dress pins, an iron knife, high-quality masonry and elaborately decorated glazed ridge-tiles all suggest that use of the earlier building (1) was of higher status than that of the later buildings (2 and 3) and the buildings in Trench 1. This agreed with the idea that this area of the castle was kept as the private residence of the lord and his family.

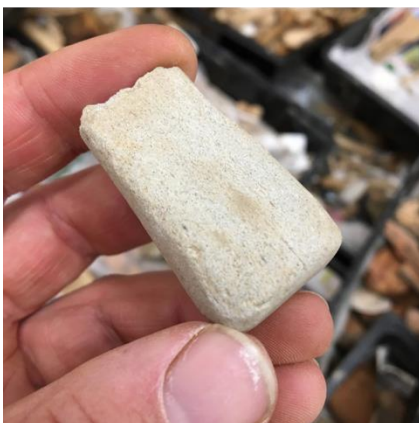
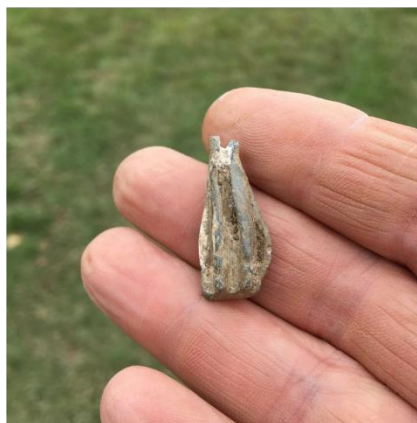
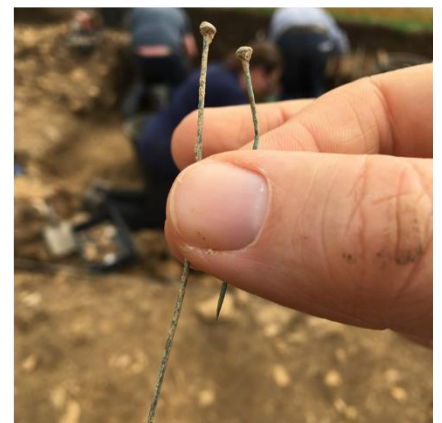
Bottom row (l-r): Part of a medieval whetstone, a lead fishing weight, and two copper alloy dress pins, all from Trench 2.

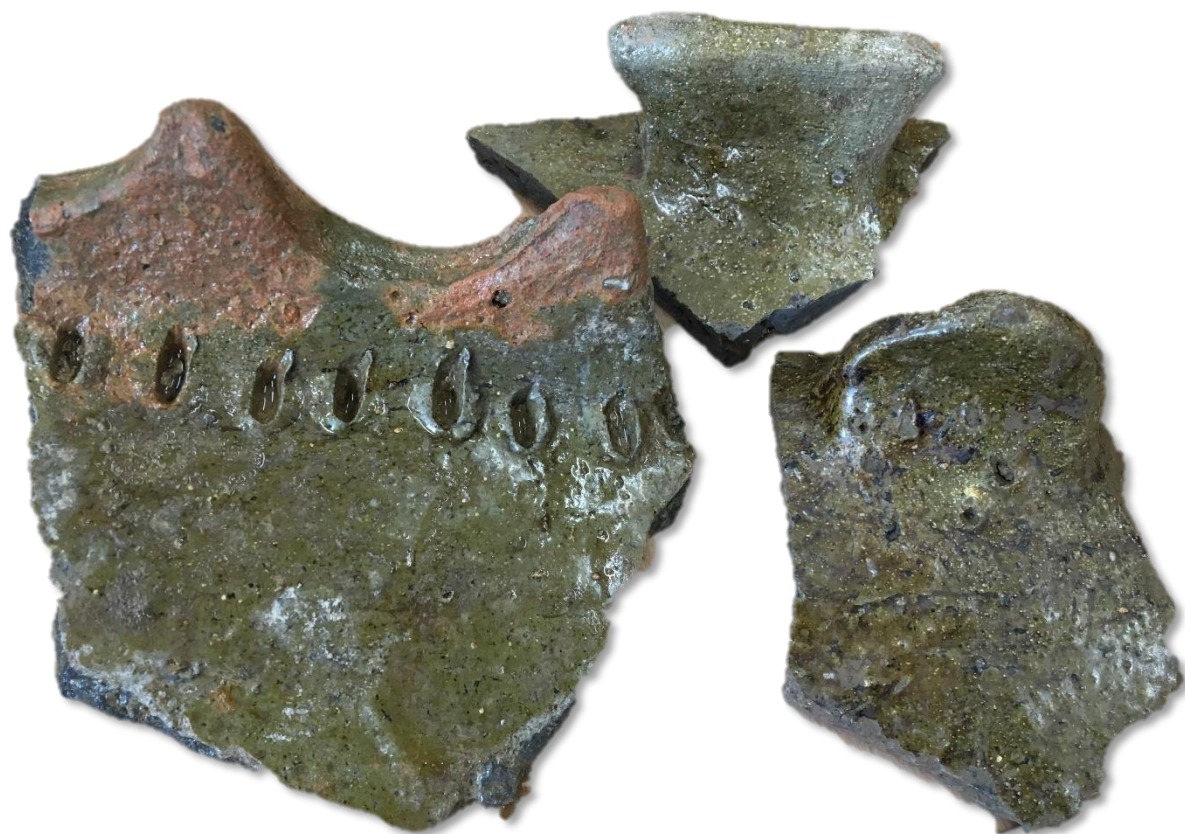
This document was published in July 2018 (© ULAS 2018). Image: Decorated glazed medieval ridge tiles from Oakham Castle.
